WALLKILL RIVER BASIN
LONG HOUSE CREEK,
PASSAIC COUNTY
NEW JERSEY

UPPER GREENWOOD LAKE DAM NJ 00186

PHASE 1 INSPECTION REPORT
NATIONAL DAM SAFETY PROGRAM
DACW61-79-C-0011

MARCH 1980

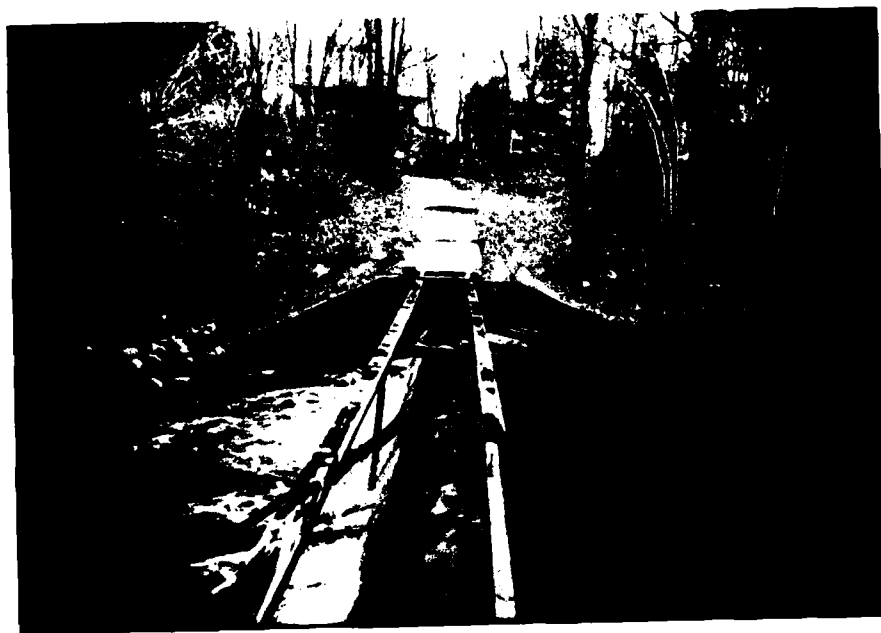
Photo 4 - View from left abutment. Note vertical cracks in abutment.

(1) Repair all cracked and spalled concrete.

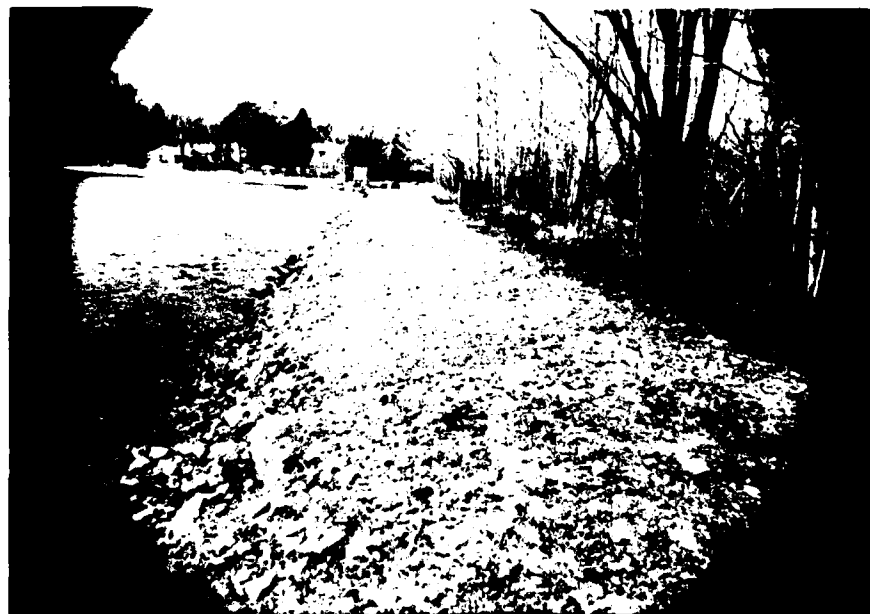
Photo 8 - View of reservoir area from spillway's left abutment.
Private beach is at upper left.

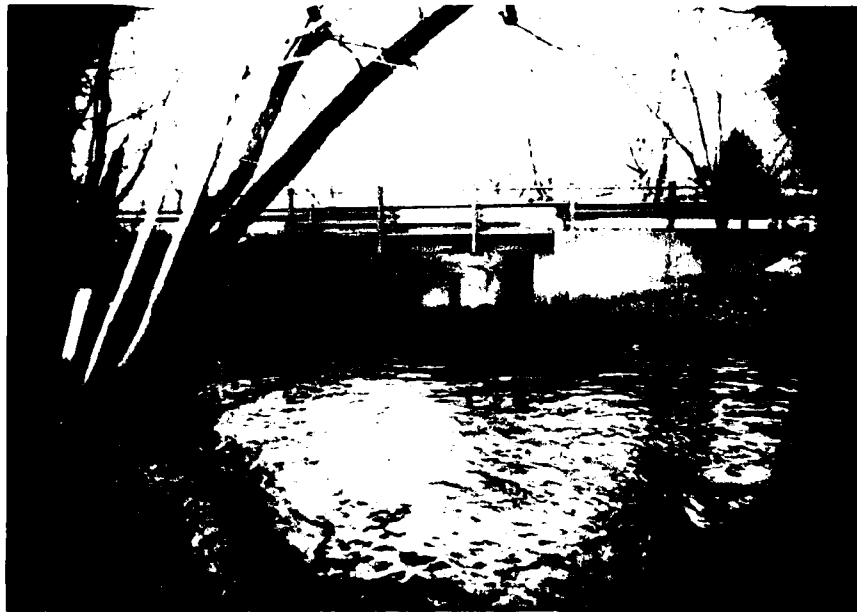
Photo 9 - View of roadway bridge (Upper Greenwood Road) crossing over channel approximately 200 feet downstream from the spillway.

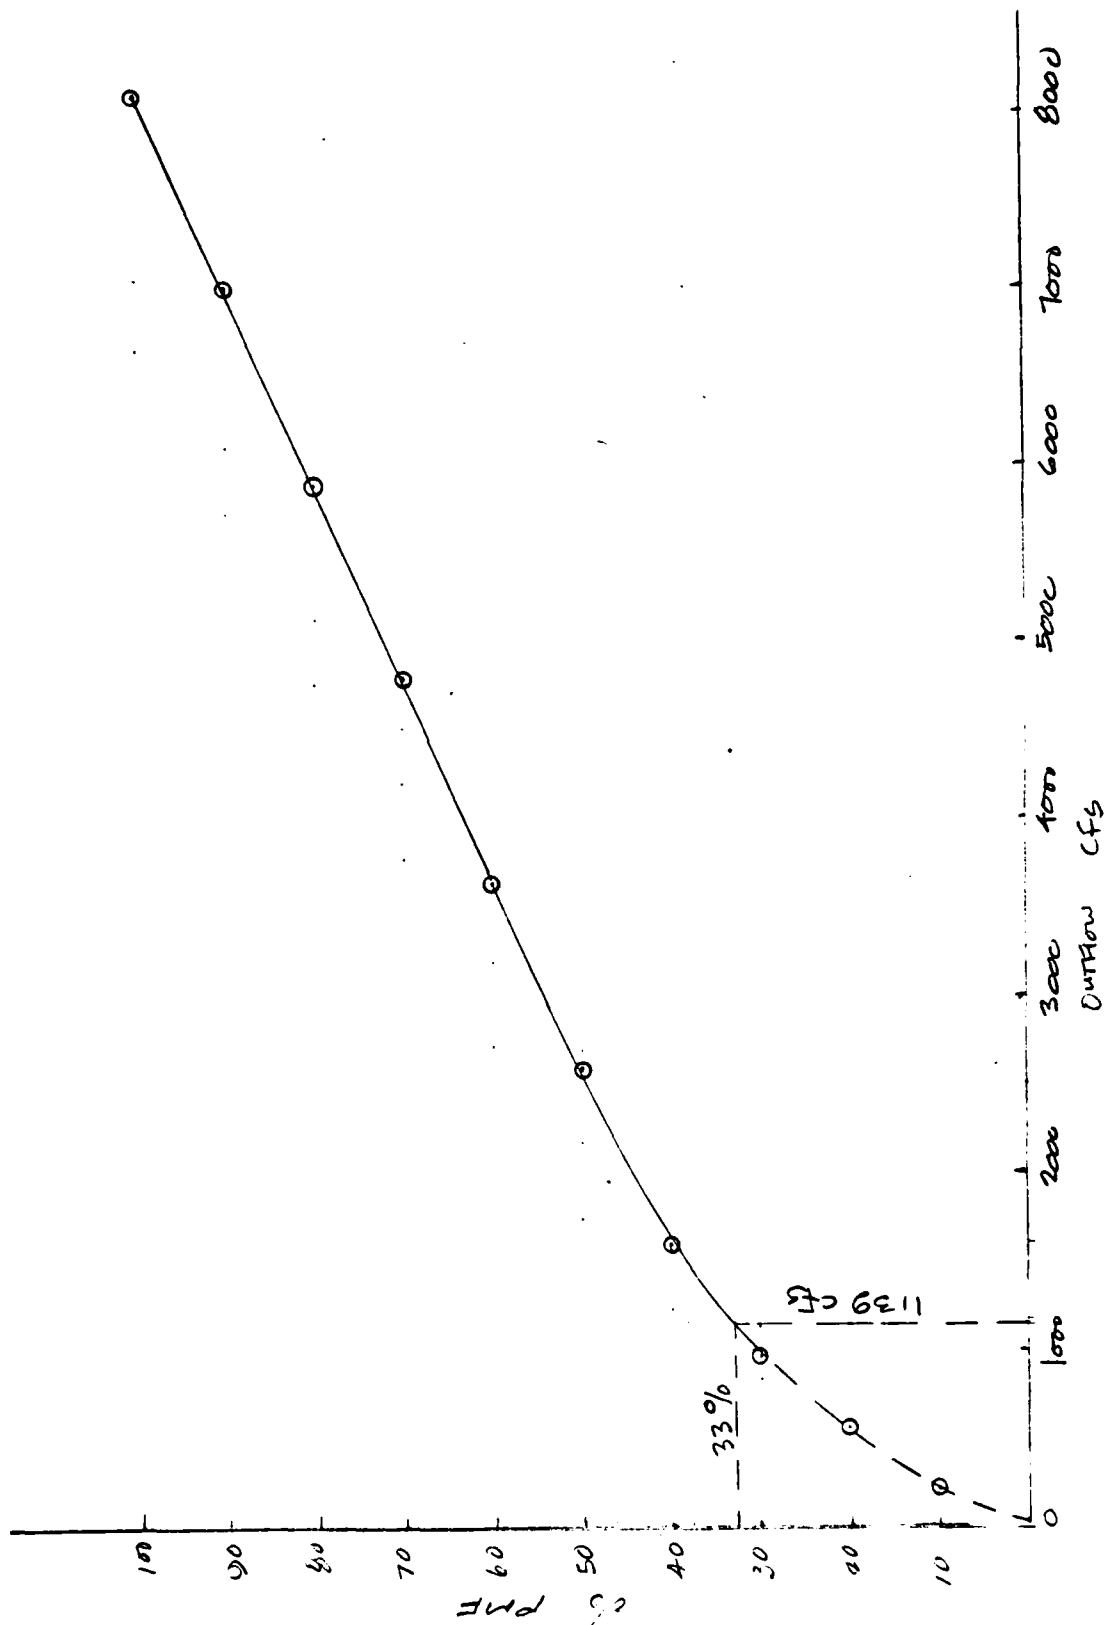
OVERTOPPING POTENTIAL

Overtopping of Dam Occurs at Ele. 1104 with $Q = 1139$ cfs ($\sim 33\%$ PMF)
